# HYDRAULIC LIME PRODUCTION COMING FULL CIRCLE?

CRISTIANO FIGUEIREDO, ALISON HENRY and STAFFORD HOLMES

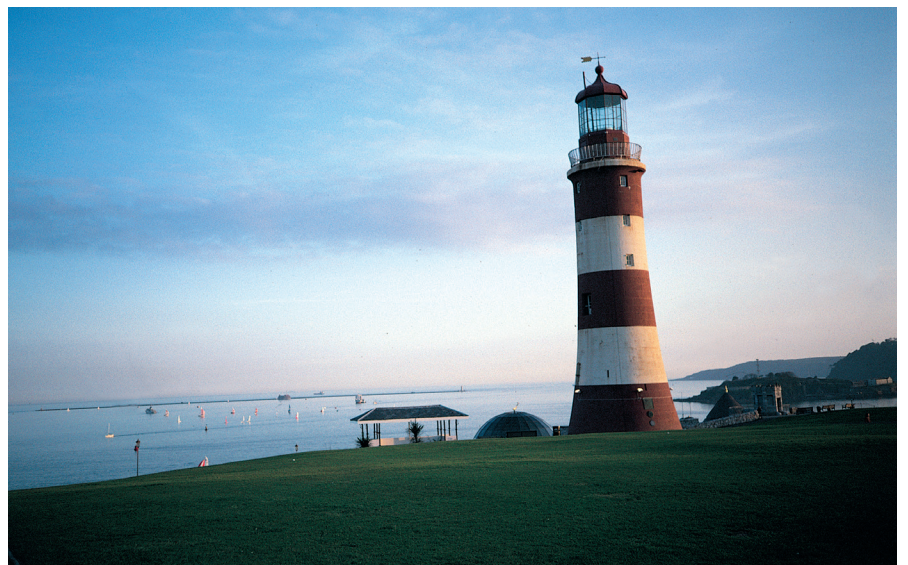
*The remains of Smeaton’s Eddystone lighthouse today. John Smeaton carried out extensive research into hydraulic lime and pozzolans to inform his design of the third Eddystone Lighthouse (1756–1759), 12 miles south of Plymouth in Devon. He settled on Blue Lias lime mixed with Italian pozzolana. The lighthouse survived for over 120 years, and only had to be dismantled because the bedrock on which it was built was undermined by the sea, causing the tower to sway in strong seas. The upper part of it was reconstructed on Plymouth Hoe, but the lower part remains in situ, as it was found to be too strong to dismantle. (Photo: John Stewart)*

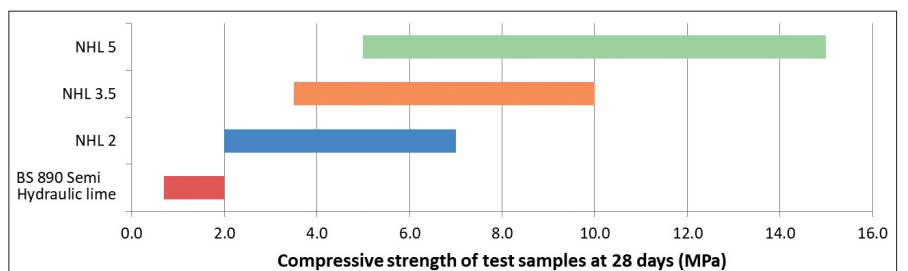
*Comparison of strengths in BS 890 and BS EN 459*

Although many practitioners and specifiers in the UK will be familiar with Cowper’s descriptive terms, most of them were never incorporated into any British standard. BS 890:1940, *Specification for Building Limes* was the first on this subject. When revised in 1966, it distinguished two classes of building lime on the basis of hydraulicity, ‘high calcium lime (white lime)’ and ‘semi-hydraulic lime (grey lime)’, as well as a class for magnesian lime. The metric edition of BS 890, published in 1972, specified that ‘semi-hydraulic lime’ should be between 0.7 MPa and 2.0 MPa. (Strengths were then given in Newtons per mm<sup>2</sup> rather than megapascals, 1 MPa being equal to 1 N/mm<sup>2</sup>.)

These definitions changed dramatically when BS EN 459, *Building Lime* was published in 1995 (see chart above). All references to ‘grey chalk’ and ‘slightly hydraulic’ lime (Cowper’s ‘feebly hydraulic’ lime) were omitted from this new standard. Lime with naturally hydraulic properties was termed ‘natural hydraulic lime’ and three types were introduced: NHL 2, NHL 3.5 and NHL 5. These had broad, overlapping compressive-strength requirements for classification, the lowest being NHL 2 with a compressive-strength requirement between 2.0 and 7.0 MPa, compared to a strength of 0.7-2.0 MPa for the BS 890 equivalent (semi-hydraulic). The strongest was NHL 5 with a requirement of 5-15 MPa. So, almost overnight, the maximum compressive strength of the strongest mortar in BS 890 became the minimum compressive strength of the weakest hydraulic mortar in BS EN 459, and there was no longer a standard applicable to feebly hydraulic lime, despite its previous widespread use. Some suppliers market NHL 2 as feebly hydraulic but this is incorrect; even the weakest NHL2 is significantly stronger than traditional feebly hydraulic lime (shown in red, above).

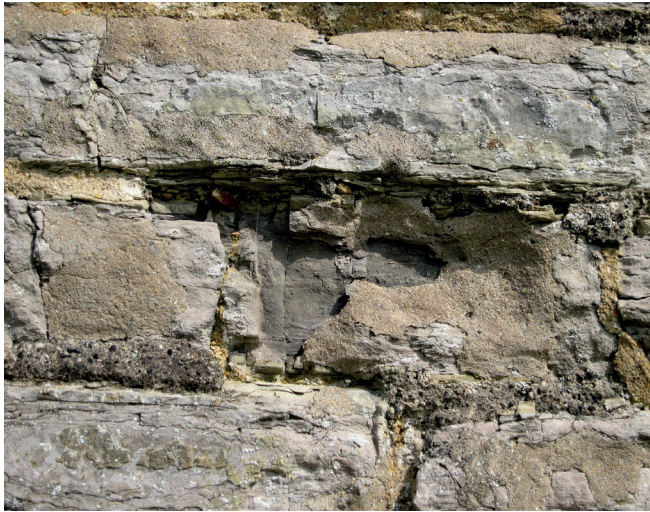
Consolidation of decaying Blue Lias stone was carried out using NHL 2 repair mortars 14 years ago. The mortar is still intact but it is not acting sacrificially, and the stone continues to decay. (Photo: Alison Henry)

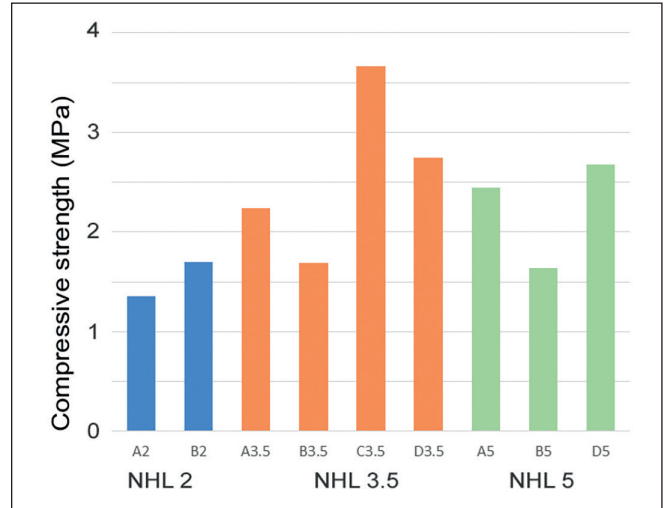
Independent analysis commissioned by Historic England revealed that the actual strengths of sampled NHLs at 28 days bore no relation to the expected strengths.

The results were surprising (below). At the end of 28 days, the two mortars with the highest compressive strength were those made with two brands of NHL 3.5. All the NHL 3.5 mortars and even one of the NHL 2 mortars were stronger than the weakest NHL 5 mortar.

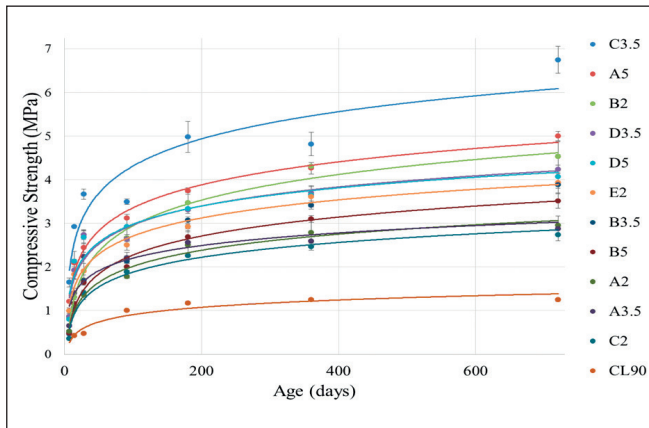
Analysis showed that measurements made at 28 days give no indication of final performance because NHL mortars continue to gain strength for many months and at varying rates. All NHLs commonly available in the UK have now been tested, and full details of each will be released by Historic England after consultation with their manufacturers.

surprising when the strengths of mortar samples at two years' age were measured. The strongest sample was still an NHL 3.5 mortar, but the third strongest was an NHL 2 mortar, which had overtaken three NHL 3.5 and two NHL 5 mortars. In fact, whereas most of the NHL 3.5 and NHL 5 mortars gained strength fairly slowly after 90 days, all but one of the NHL 2 mortars continued gaining strength at a steady rate, overtaking many of the mortars made with binders in a higher strength class, including the mortars made with NHL 3.5 lime from the same manufacturer as each NHL 2 being tested. This demonstrates that not only is there significant variation in strength between limes from different manufacturers, but that even within an individual manufacturer's product range, the NHL 2 binder may end up stronger than the NHL 3.5.

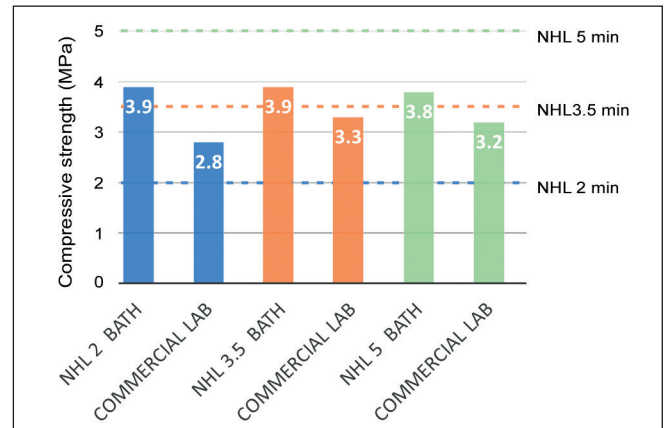
Mortar samples made with different batches of NHL from one manufacturer were tested strictly in accordance with BS EN 459 at the University of Bath and at an independent commercial laboratory. Neither batch of NHL 5 met the minimum strength required by the standard, and results from the two labs varied significantly. This is further evidence of the inconsistency of NHL binders and the fact that classification according to the standard cannot be used as a reliable guide to mortar properties.

To validate these results, 'standard' samples of mortars were made and tested at the university and by an independent commercial laboratory, strictly in accordance with the standard methodology required by BS EN 459. The binders used were all from the same manufacturer, but from different batches purchased from different suppliers. Both the NHL 2 samples tested exceeded the 2 MPa minimum compressive strength at 28 days required by the standard, although the values achieved by the university and the commercial laboratory were significantly different. While the values obtained for the NHL 3.5 were closer in both labs, the NHL 3.5 tested at the commercial facility failed to meet the minimum 3.5 MPa at 28 days specified by BS EN 459, and the NHL 5 tested in both labs fell far short of the required minimum strength. All three binders tested at the university achieved virtually the same compressive strength at 28 days when tested according to BS EN 459, regardless of the classification on the bag (see Comparison table, above).

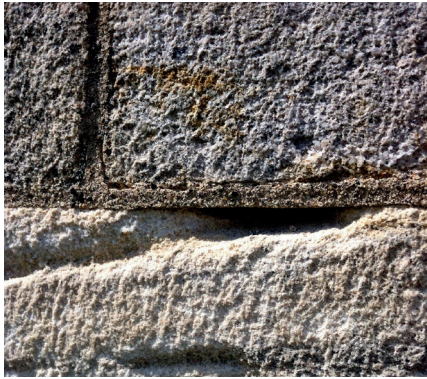
18 years after being repointed in NHL 3.5 mortar, this sandstone is decaying while the pointing remains intact. The mortar is not acting sacrificially to protect the stone. (Photo: Sam Baxter)

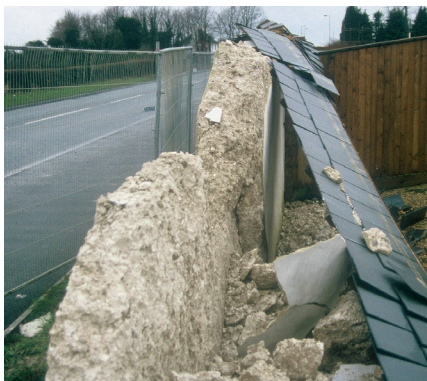
A chalk cob wall had been rendered with an NHL 3.5 render, trapping moisture inside the cob which led to its collapse. (Photo: Kevin Stubbs)
