Conserving War Memorials

Case Study: Cleaning

First World War Memorial, Cheltenham,
Gloucestershire

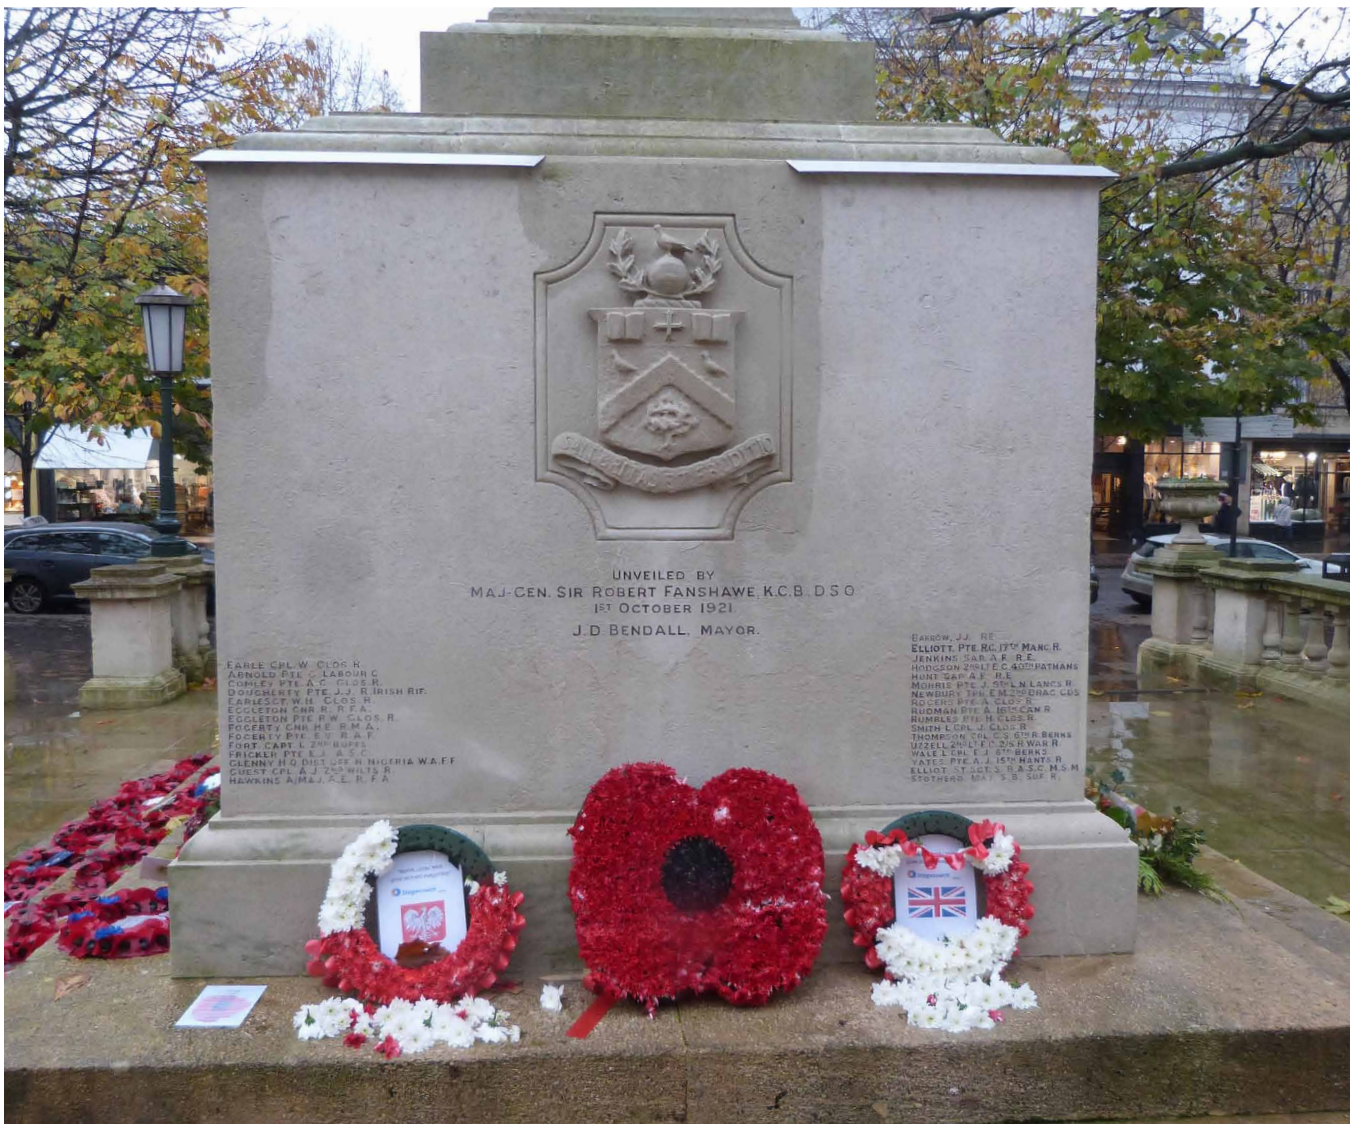
Front cover:

The Cheltenham war memorial after cleaning.

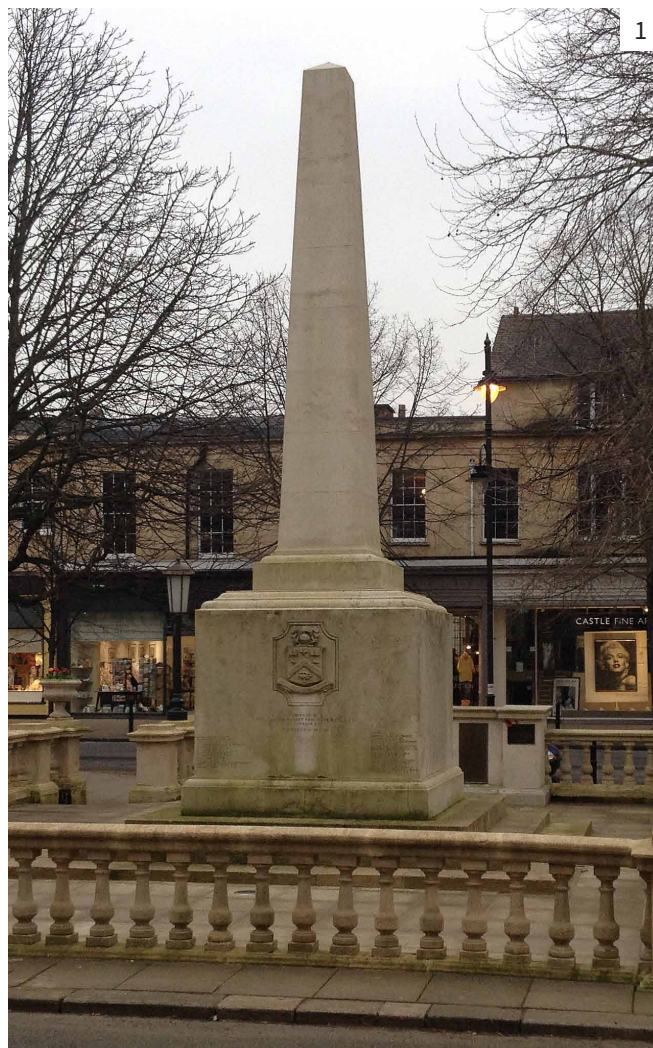
The memorial was constructed in 1921 and consists of a Portland stone obelisk on top of a large base set on a stepped plinth. The most notable element of the memorial is the extent and nature of the inscriptions: 1284 names are inscribed on three sides of the base. The letters were cut so as to receive lead fills but whether from cost or unavailability of craftsmen, the incisions were actually filled with coloured cement mortar with an oiled finish to simulate lead.

1 The Cheltenham War Memorial.

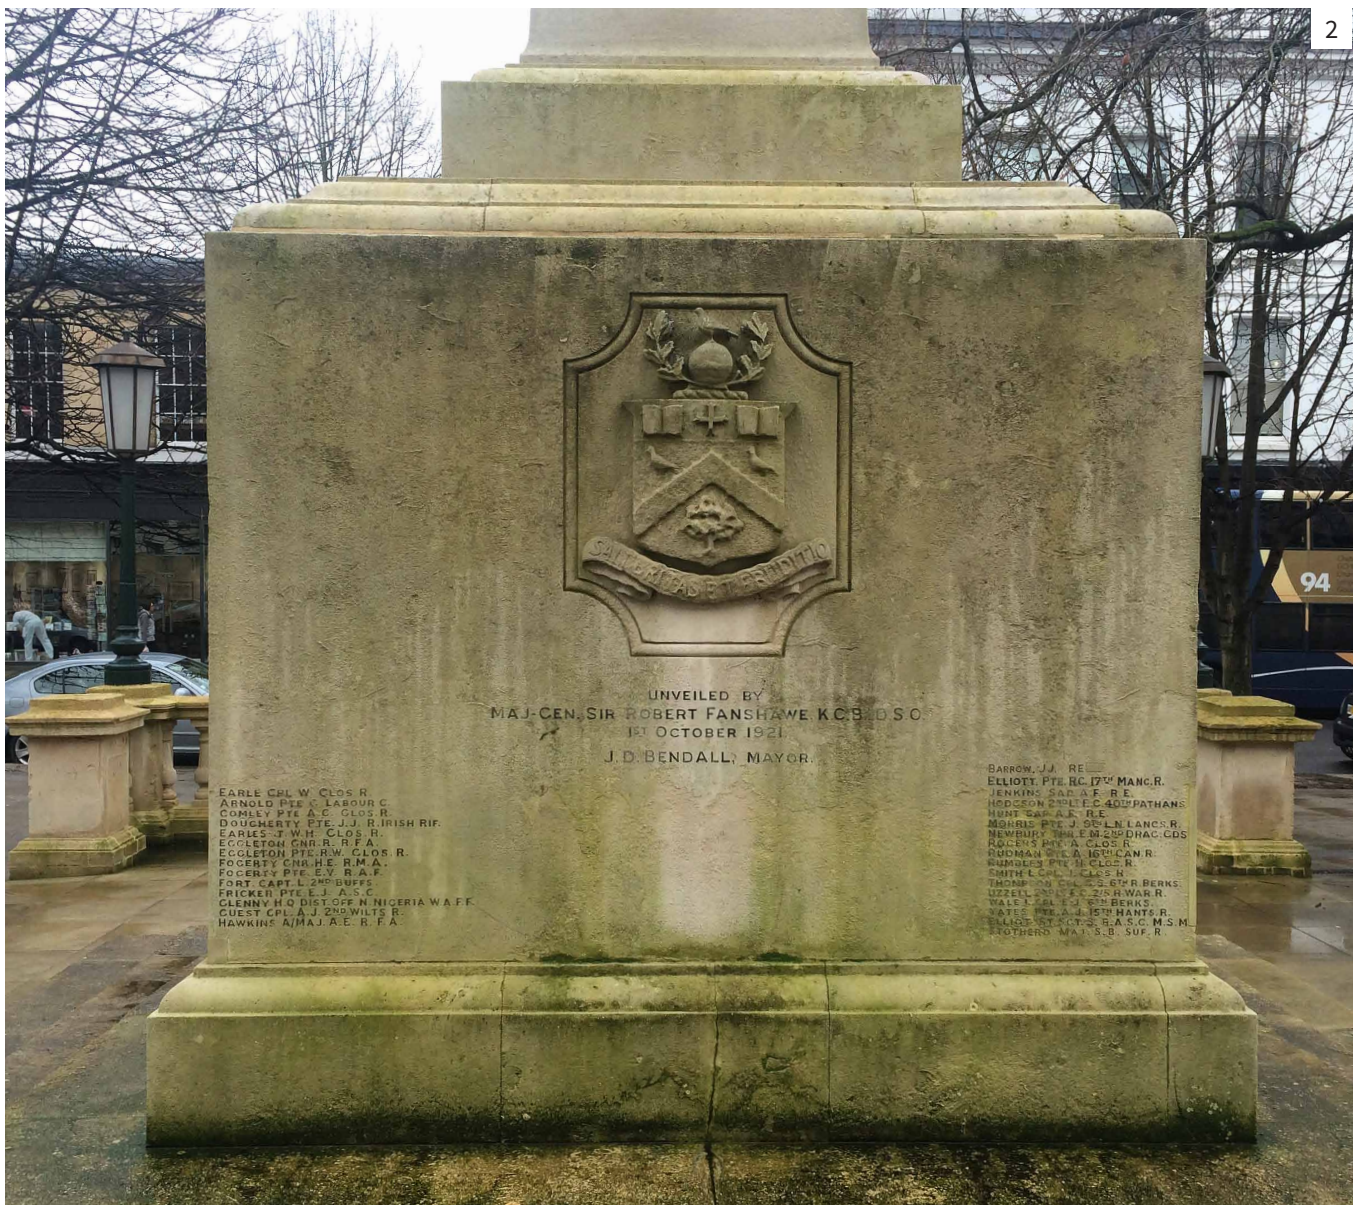
The local environment – with overhanging trees – and the porous nature of the stone meant that there existed ideal conditions for the growth of algae and most areas of the memorial were affected.

In addition, the original design allowed water to track down the obelisk and because there was no overhanging moulding this resulted in saturation of the top of the inscription panel and significant algal and lichen growth. As a result of this, inscriptions – particularly those in the upper parts of the panels – became obscured. In order for legibility to be restored, the memorial was therefore regularly cleaned, usually with pressurised water. Unfortunately this cleaning process caused the edges of the inscriptions to become worn, with a consequent loss of some of the mortar infill.

2 View of Cheltenham war memorial showing algal and lichen growth on west side.

Initially the work involved the removal of microbiological growth from all areas of the memorial, and in particular from the inscriptions. For the obelisk and other plain areas, a superheated water system was used operating at 150°C. This has proven ability at removing algae but there is no evidence that the heat generated on the stone is sufficient to allow sterilisation and eradication of the root systems.

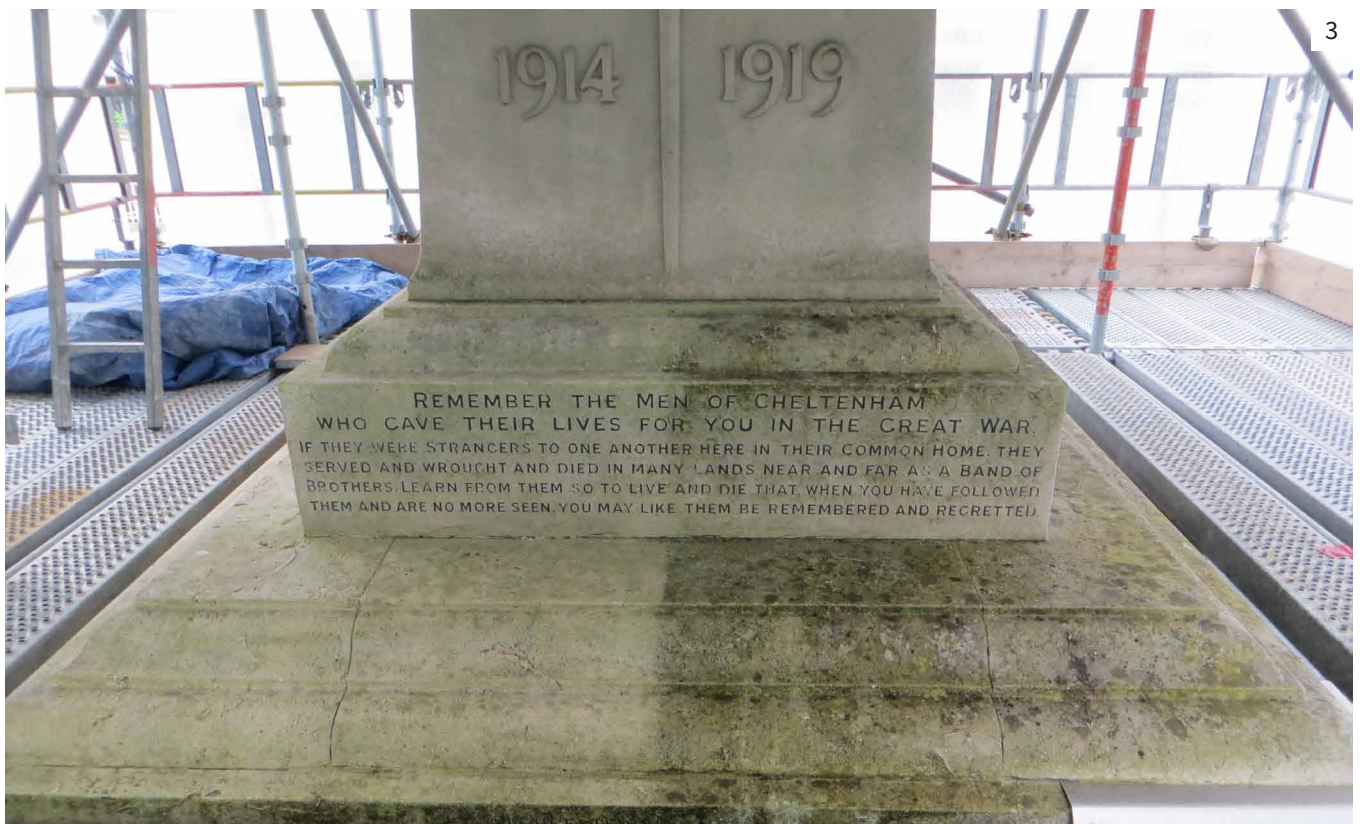
3 The left hand side of the memorial has been cleaned using super-heated water.

The first of these options was found to just smear the algae evenly over the surface without removing it. The second was effective but lacked the required finesse. There were two main disadvantages: the amount of water that runs down the face, and the clouds of steam that made seeing the surface, and therefore controlling the extent of cleaning, difficult.

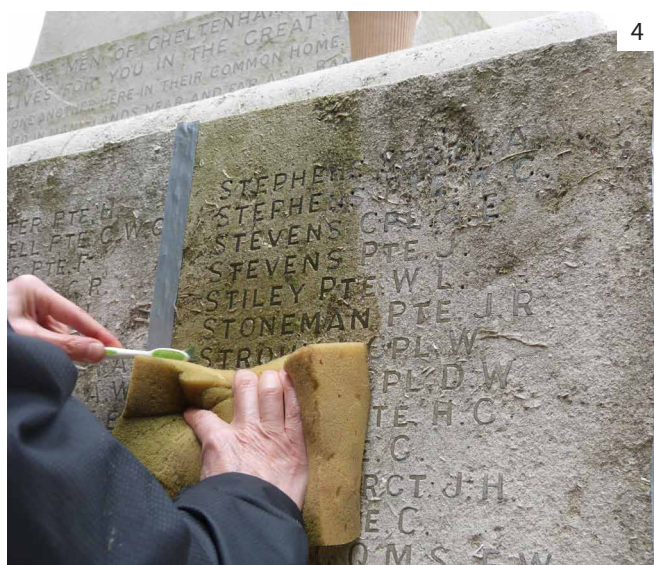
- 4 The wet brushing caused the green from the algae to be smeared evenly across the surface without removing it from the pores.
- 5 The type of dry steam machine capable of delivering steam at 160° C.
- 6 The brush head generates small amounts of steam with little water run-off.

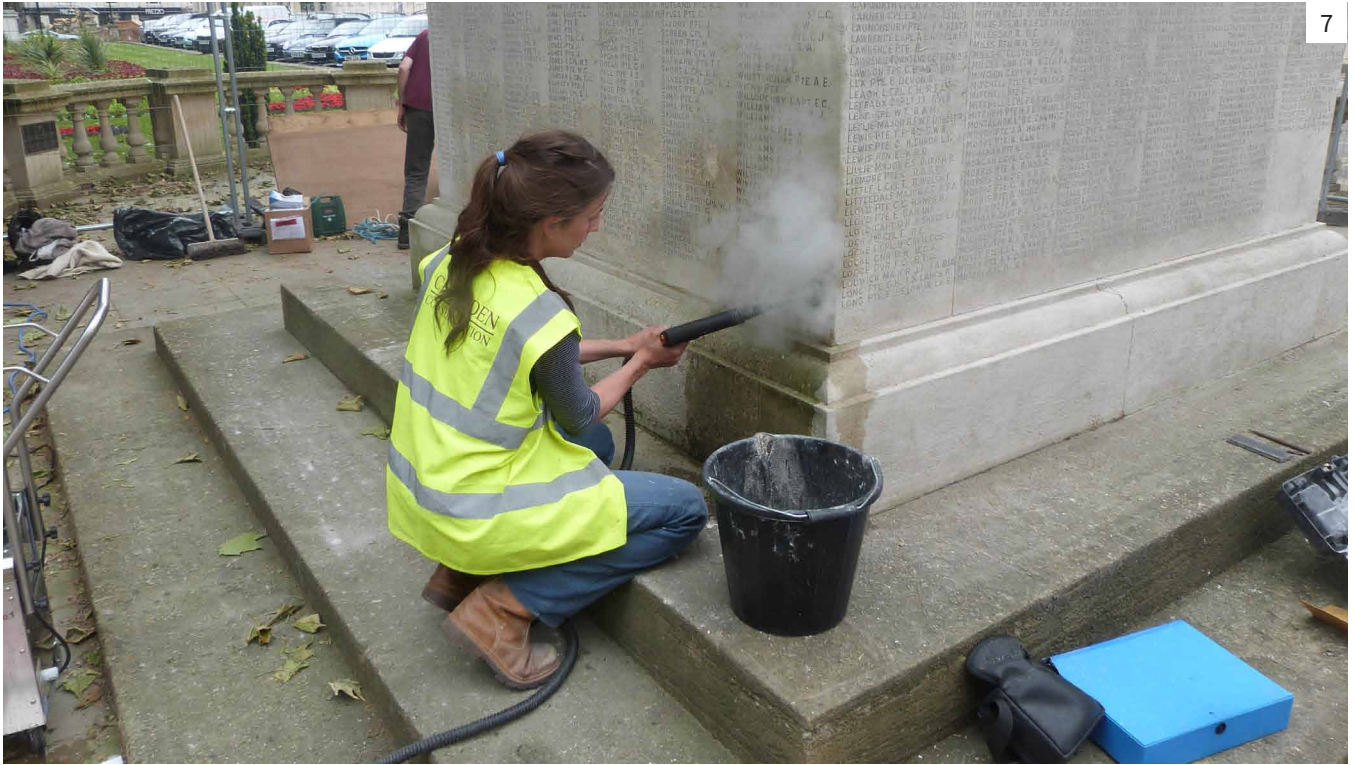
- 7 The dry steam process allows more careful control of the cleaning.
- 8 South side with one half having had first pass of cleaning with dry steam.
- 9 After completion of cleaning using two passes of dry steam.

The third option used a stiff bristle brush on the end of a lance through which dry steam was passed. This proved most effective and has the advantage of very little pressure, the introduction of much less water and more heat that might sterilise the hyphae. Best results were achieved by carrying out one pass of the surface followed soon after by a second pass.

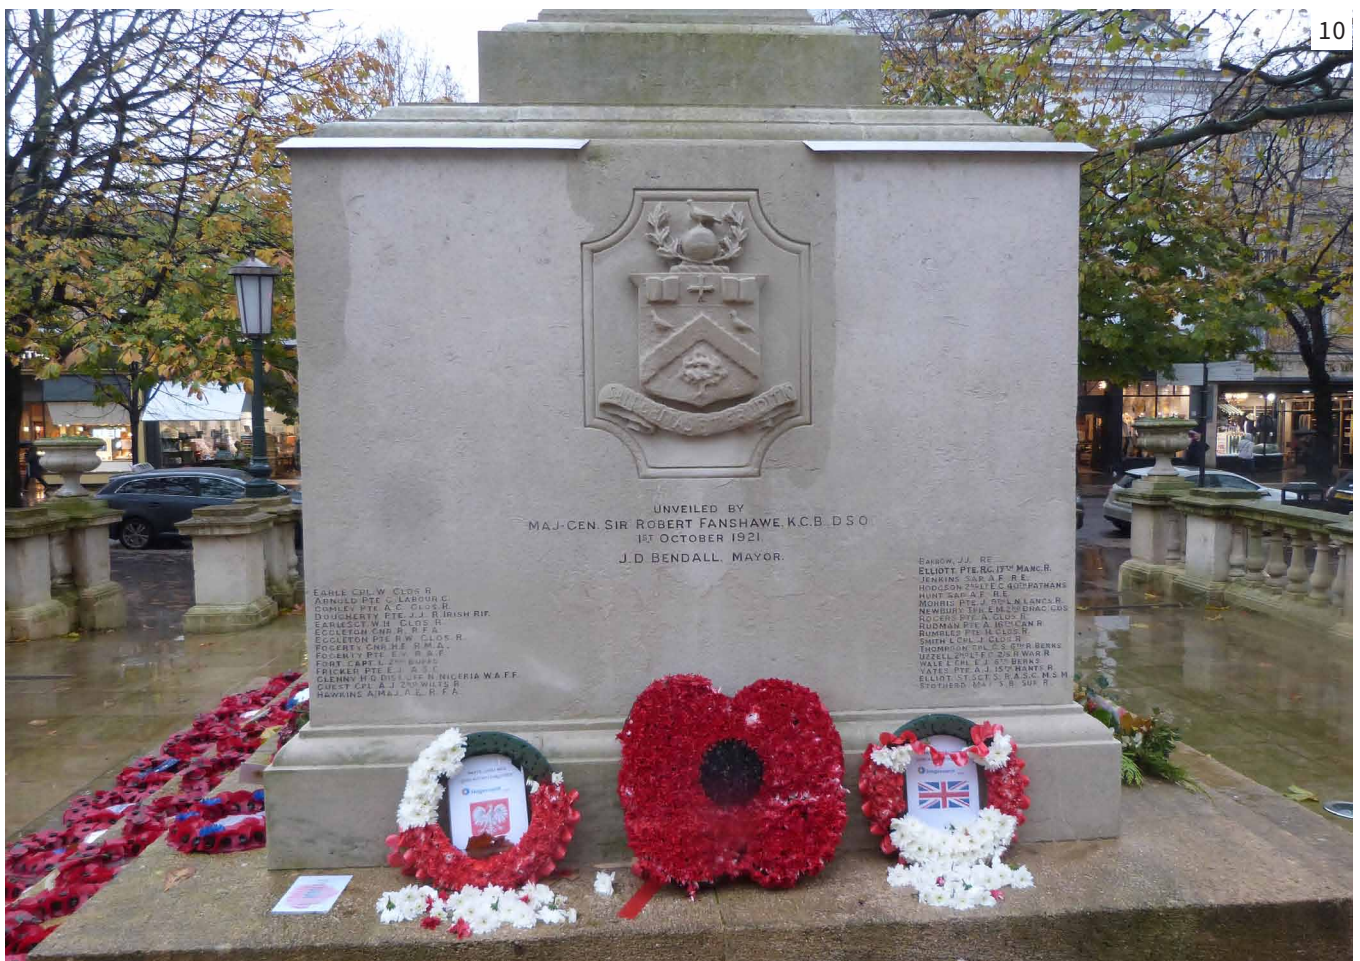
10 West side after completion, with flashing in place. The upper areas of the memorial are developing surface algae after only a few months.

The project demonstrated the importance of considering why there is a need to clean, and to fully explore the various options. The challenge for the future is preventing the cycle of algal growth and re-establishing regular cleaning. One option that has been adopted is the installation of a flashing let into the joint above the inscription panels. This will prevent water running over the panels and should reduce algal growth; the effect is being monitored for two years.
